## Dam safety in China and the life span evaluation of old concrete dams

Jinsheng Jia & Cuiying Zheng

## 2 MAIN PROBLEMS AFTER NEW COMPREHENSIVE EVALUATION ON FENGMAN DAM

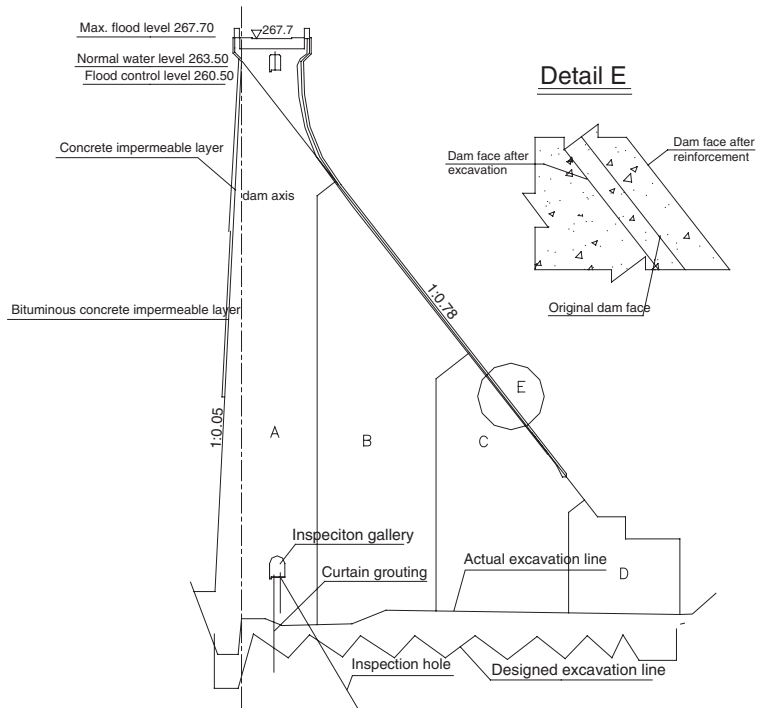
Figure 1. Typical cross section of dam.

Fengman concrete gravity dam is situated at the main stream of the second Songhua River, 24 km to downstream Jilin City, Jilin Province. It is situated in severe cold area. Its mean annual temperature is 5.3°. The highest mean monthly temperature is 24.3° and the lowest is -19.7°. The maximum height of the dam for its original design was 90.5 m and the dam crest elevation is 266.5 m. Dam construction started in April 1937 and water impounding started in Nov. 1942. The project was completed and operated in Oct. 1953. By the end of reinforcement in 1996, the maximum dam height is 91.7 m and the dam crest elevation is 267.7 m. The dam crest is 1080 m long, divided into 60 dam sections, each of which is 18 m long. Arranged from the left to the right bank, the 9th to 19th dam sections of the dam are overflow dam sections, the 21st to 31st are intake sections for power generation. The upstream slope of dam section is 0.05 and downstream slope is 0.78. During the construction, the dam cross section was divided into A, B, C and D blocks by the longitudinal joints. The typical cross section after reinforcement is as shown in Fig. 1.

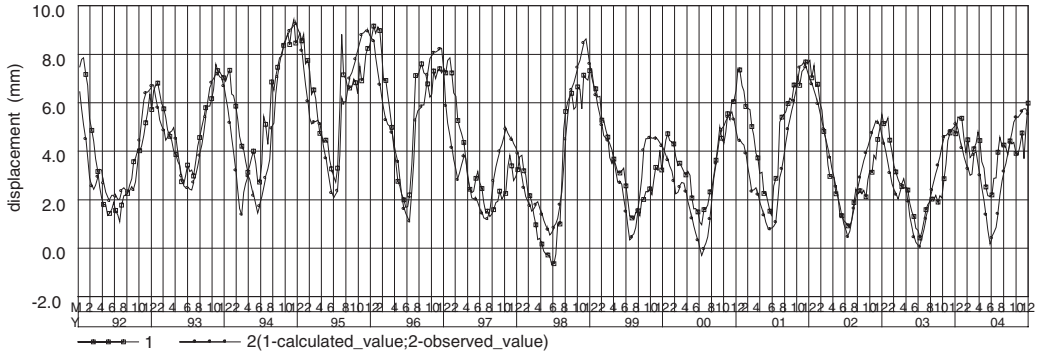
Figure 2. Calculated horizontal displacement compared with observed data at dam top of BL 47.

According to the whole course simulation calculation, temperature field, stress field and displacement field of BL47 at any time can be obtained. Comparing the horizontal displacement at dam top obtained by simulation analysis with measured data (See Fig. 2), it can be found that these two are consistent with each other, which indicates that the simulation analysis can reflect the practical operating condition of the dam.

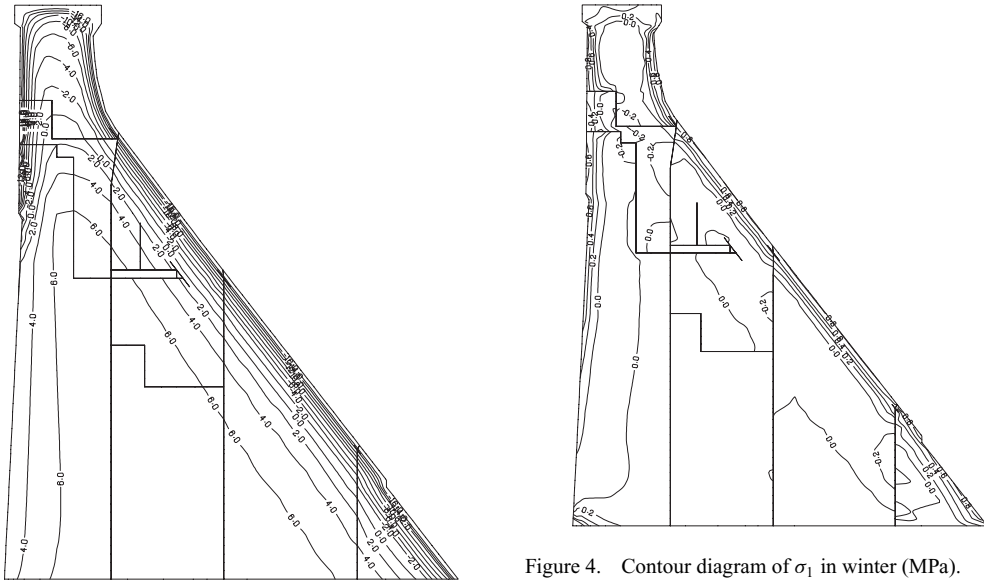
Figure 3. Envelope diagram of minimum temperature during operation (°C).

According to the envelope diagram of minimum temperature field during operation from 1990 to 2005 (Fig. 3), negative temperature may occur in concrete of dam top and downstream side during winter, which may cause frost thawing fracture due to sever seepage in dam concrete. The depth of negative temperature zone of downstream side is about 4.5 m. According to the contour diagram of  $\sigma_1$  in winter (Fig. 4), tensile

stress with maximum value of 0.8 MPa is distributed in area of dam shell, in most part of which concrete has low tensile strength of about 0.5 MPa. The depth of tensile stress zone of downstream side is about 3.2 m. Furthermore, tensile stress of 0.2–0.8 MPa is

distributed in dam heel with width of 6 m or so. Calculated results show that the value and distribution area of tensile stress in dam heel may decrease, while tensile stress distributed in concrete of dam center way cause longitudinal joints and construction joints to open.

To increase the safety of Fengman dam, it is an option to add new concrete on the downstream face. When 4-meter-thick concrete layer is added, overload coefficient will increase to 2.33–2.47 even no reinforcement is done to longitudinal joints and safety factor of sliding resistance along dam base will increase more than 17%, which will meet the requirements of sliding resistance.

(1) Adding new concrete with 4 to 6-meter-thickness on the downstream face

Thickening the dam along downstream face will increase the safety of the whole dam and also make

negative temperature and tensile stress transfer to new high strength concrete, which will improve safety of the dam to a similar new one.
